DEPARTMENT OF TRANSPORTATION

Quality Assurance and Source Inspection

Contract #: 04-0120F4Cty: SF/ALA Rte: 80 PM: 13.2/13.9File #: 69.28**WELDING INSPECTION REPORT****Resident Engineer:**Siegenthaler, Peter**Address:** 333 Burma Road**City:** Oakland, CA 94607**Report No:** WIR-017393**Date Inspected:** 27-Sep-2010**Project Name:** SAS Superstructure**OSM Arrival Time:** 700**Prime Contractor:** American Bridge/Fluor Enterprises, a JV**OSM Departure Time:** 1900**Contractor:** Zhenhua Port Machinery Company, Ltd (ZPMC), Changxing Island **Location:** Shanghai, China

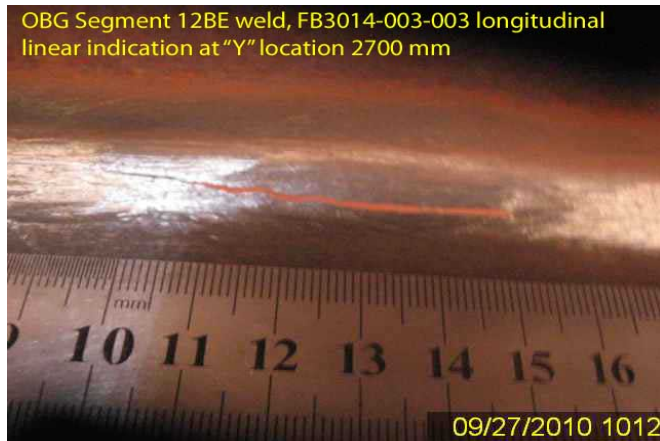
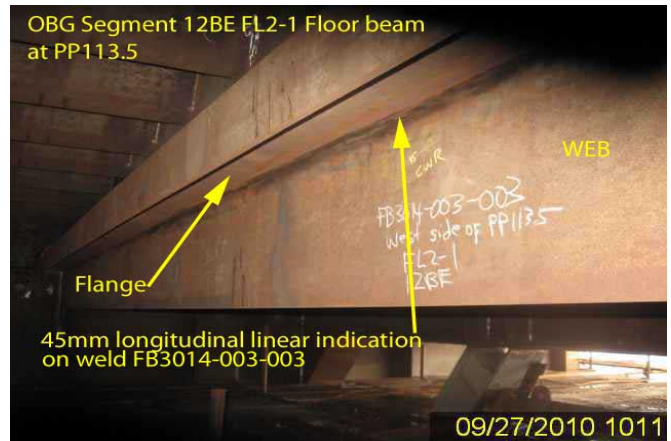
A longitudinal crack measuring 45mm was found at "Y" location 2700mm on weld FB3014-003-003. A Incident report was issued this date for the above mentioned crack. See attached photo below for additional information.
